Periodic Inspection Report No. 4
West River
Townshend, Vermont

Townshend Lake

October 1996

US Army Corps
of Engineers

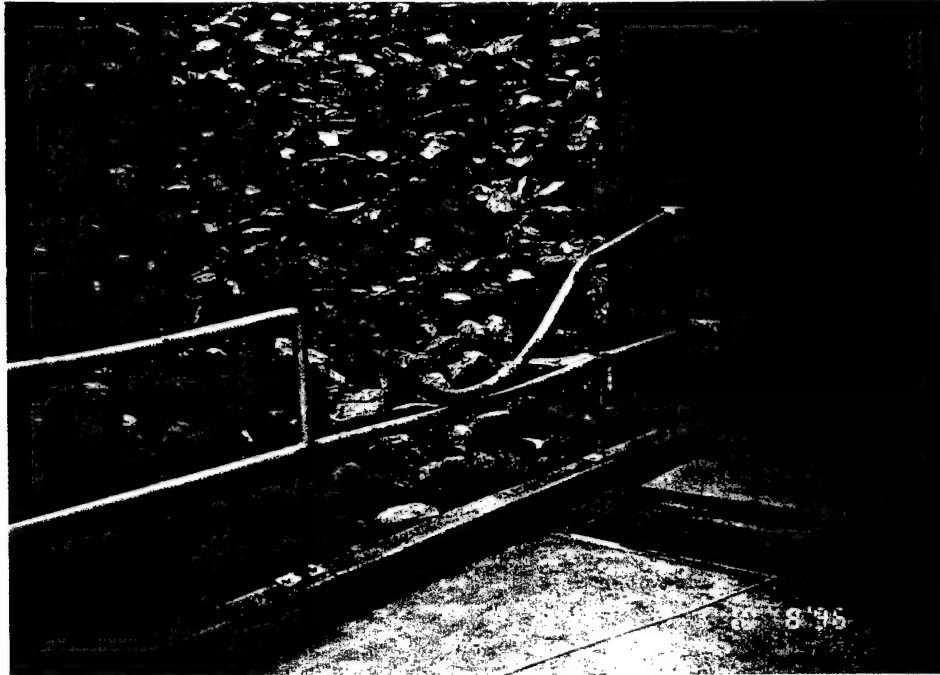
PHOTO A-9. Damaged railing section at the south east corner of the upstream control platform.

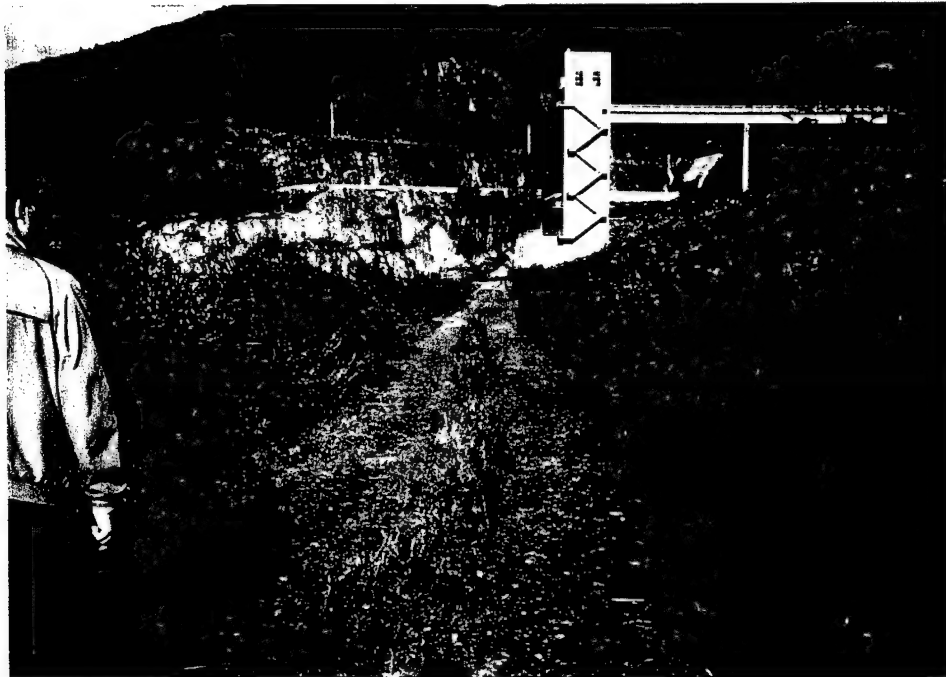
PHOTO E-5: View of edge of lower portion of upstream impervious blanket. Note heavy brush growth.

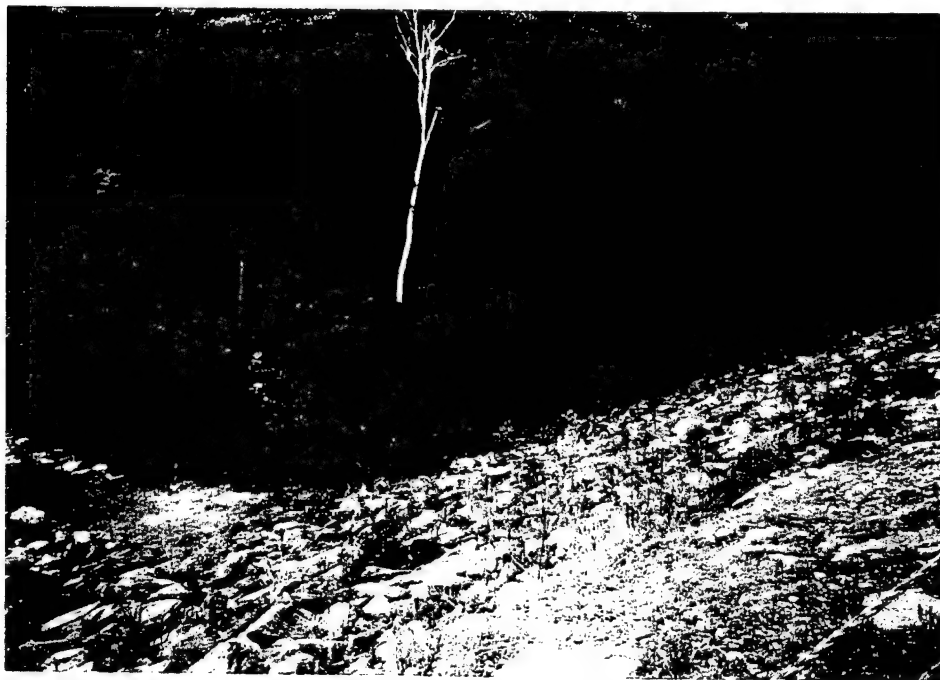
(3) Downstream Slope. The rock fill slope is in good condition and appears stable with no indication of movement or sloughing. Sparse brush growth was observed on the slope. See Photo E-8, Appendix II.

PHOTO E-8: Closeup view of downstream toe above rock
fill blanket (area noted by arrow in Photo E-7).
Note large trees and brush growth.

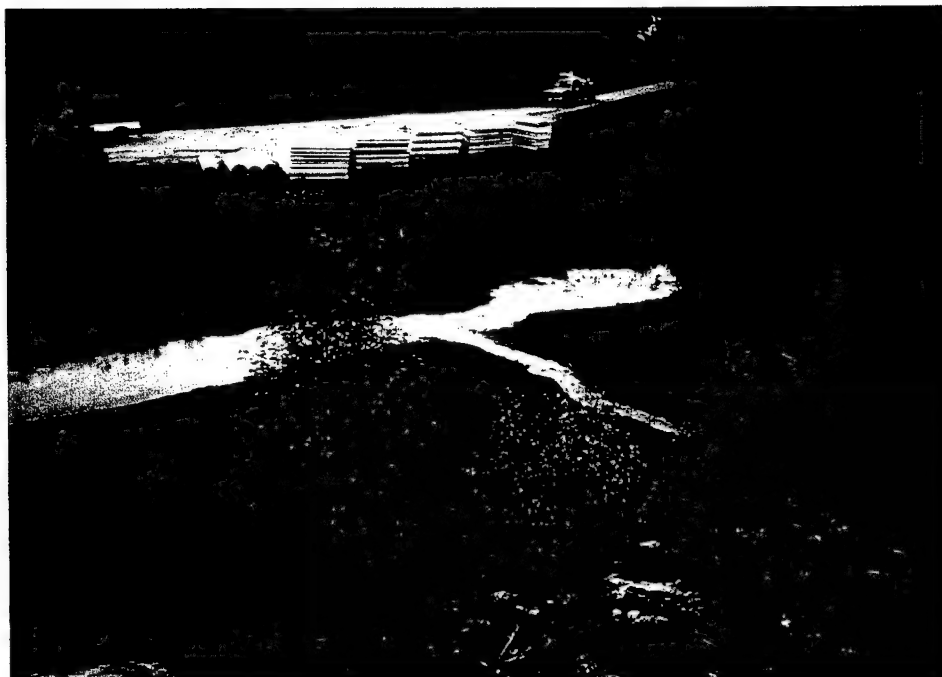
(4) Seepage. Townshend Dam has a history of seepage problems including piping and boils along the downstream toe. On the day of the inspection, flow of about 5 to 10 gpm was observed at a point along the toe of the downstream slope, within the measuring pool. See Photos E-9

PHOTO E-9: Seepage emerging from downstream toe within the seepage pool. Flow was estimated at 10 gpm.

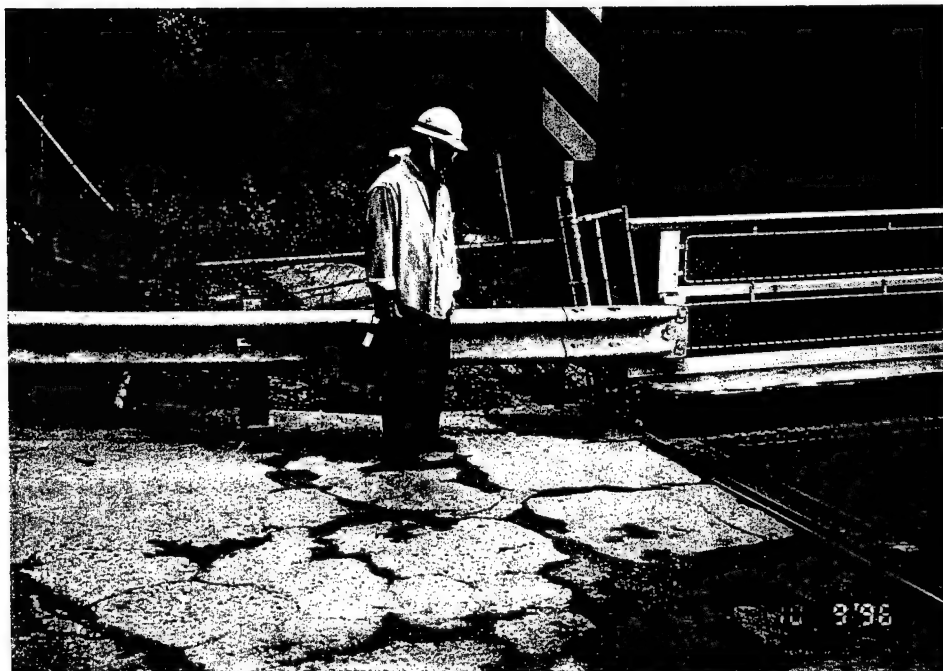
(4) Access Bridge Over Spillway. There is no indication of movement of the concrete abutments. Alligator cracking in the concrete surface in the roadway approach lip is caused by deterioration of the concrete rather than by movement of the abutment. See Photo E-16, Appendix II. Overall condition of exposed rock is good. The structural condition of the bridges at this project are evaluated in the Bridge Inspection Program. The last inspection of the spillway bridge was performed in 1996, and is in good condition. The service bridge is scheduled to undergo an Inventory Inspection in FY97.

PHOTO E-16: Left side of spillway bridge. Note alligator cracking on asphalt and damaged safety fence.
